## Home Inspection Report

Peter Seebach  
1016 Linden St S  
Northfield, MN 55057

Jonathan Fredrickson  
Premier Property Inspections  
02/28/2025

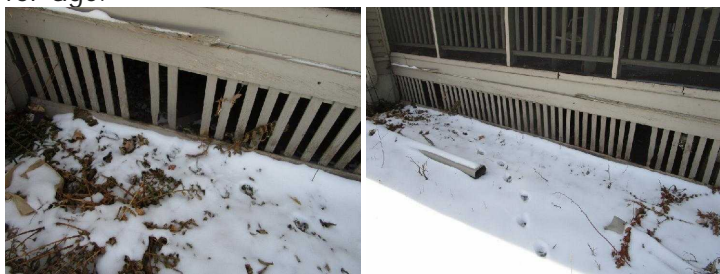
Several areas of the skirting under the screened porch are damaged/missing spindles.

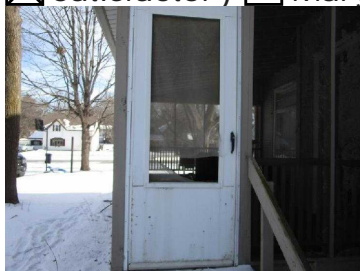
Screen porch storm door is in disrepair.

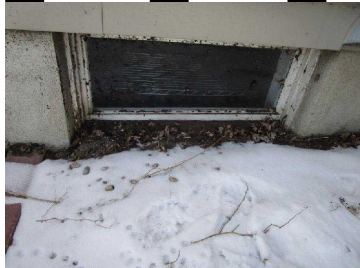
One window well is needed for the rear basement window.

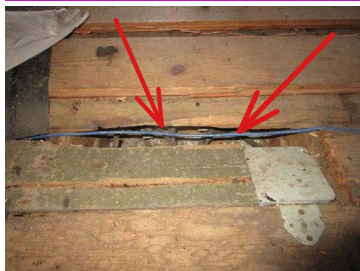
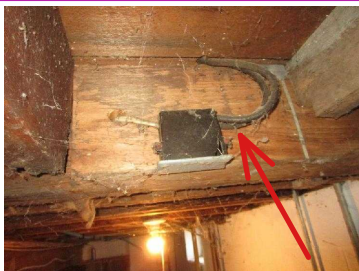
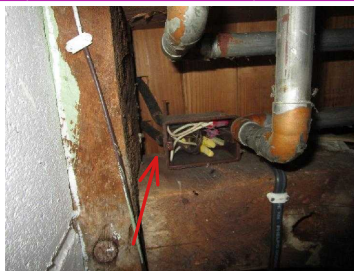
ELECTRICAL- Active knob and tube wiring was present in the attic space and basement, wiring is obsolete and rated as marginal due to age.

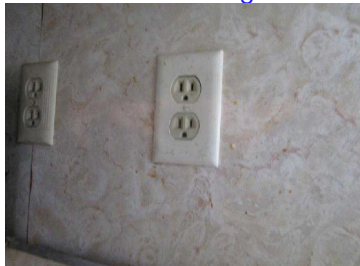
ELECTRICAL- Kitchen countertop receptacles should be GFCI protected for safety.

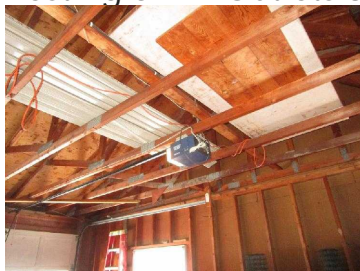
Extension cords are not recommended for permanent use, currently this is present in the garage operating the south garage door.

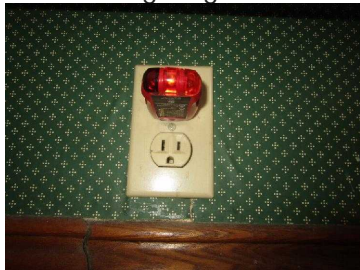
ELECTRICAL- Approximately 15-20% of the receptacles were testing for false/open grounds, this is likely caused from the original two wire system being converted to a modern three prong/grounded receptacle however no grounding is present.

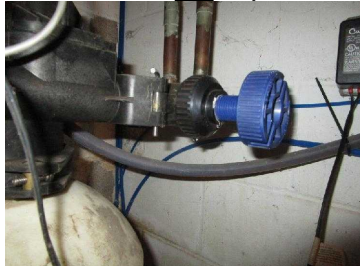
PLUMBING- Water softener has a slow drip behind the head unit.

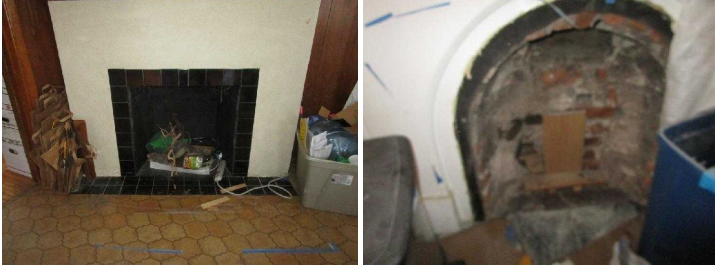
**FIREPLACES-** A visual inspection was conducted on the wood burning fireplaces. It was observed that many areas of missing and decayed mortar was observed along with non operational dampeners. Fireplaces should not be used due to risk of fire.

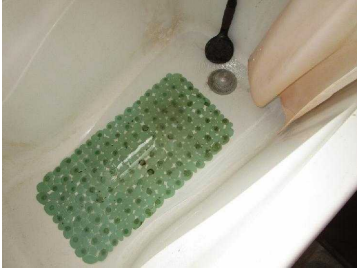
Tub drains slowly.

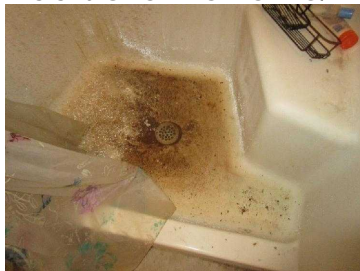
LOWER BATHROOM- Shower base has water stains indicative with sewer back ups. No issues were found at time of inspection, sewer line may need to be inspected.

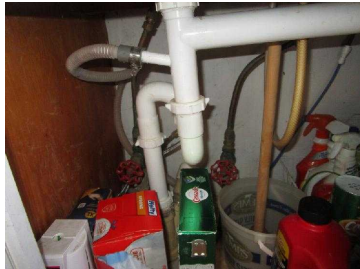
Sink was not properly vented, drain gurgles when in use.

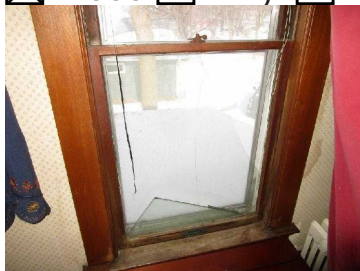
UPPER BEDROOM NORTH- Lower window pane was broken.

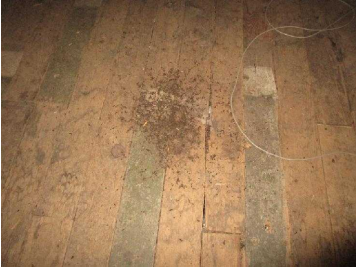
ATTIC- Many areas of rodent droppings were present in space which appear to be caused from bats. Activity does appear to be older however this cannot be definitively determined. Recommend a further evaluation by a qualified pest control specialist.
